**RE: City of Teague
8th Avenue Park Pavilion
Structural Recommendation Report**

January 10, 2019

Reference: Teague City Park Pavilion

Regarding: Structural Evaluation

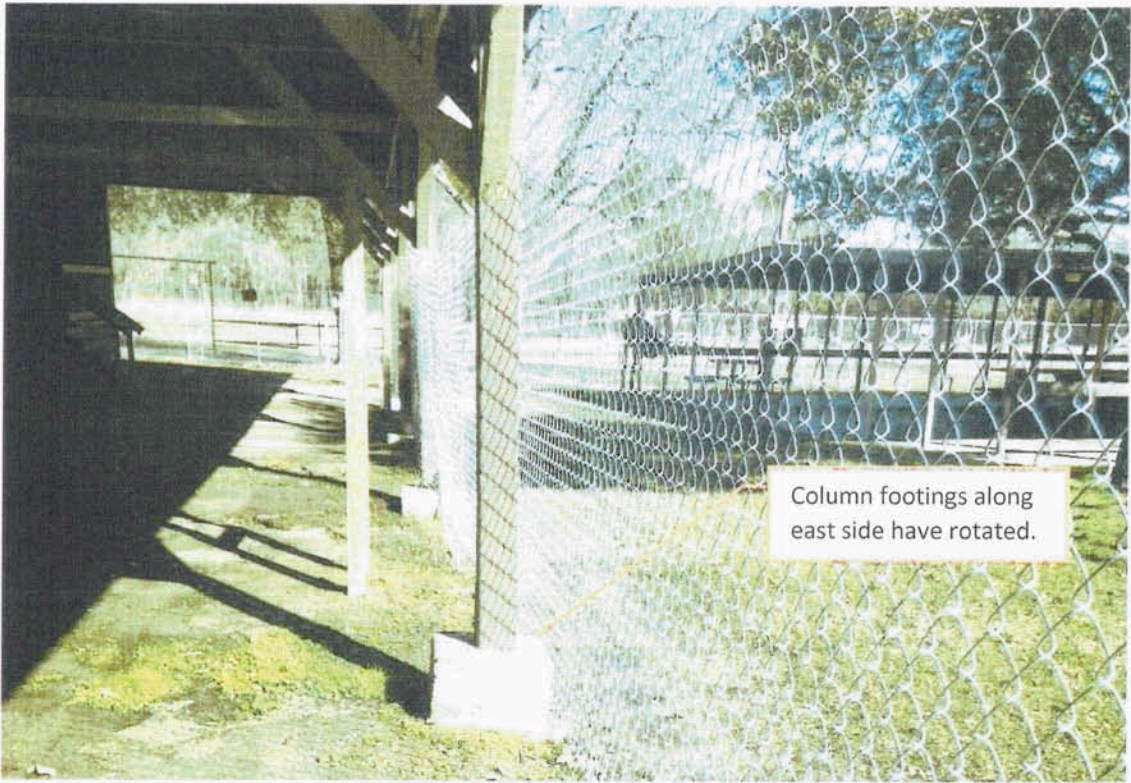
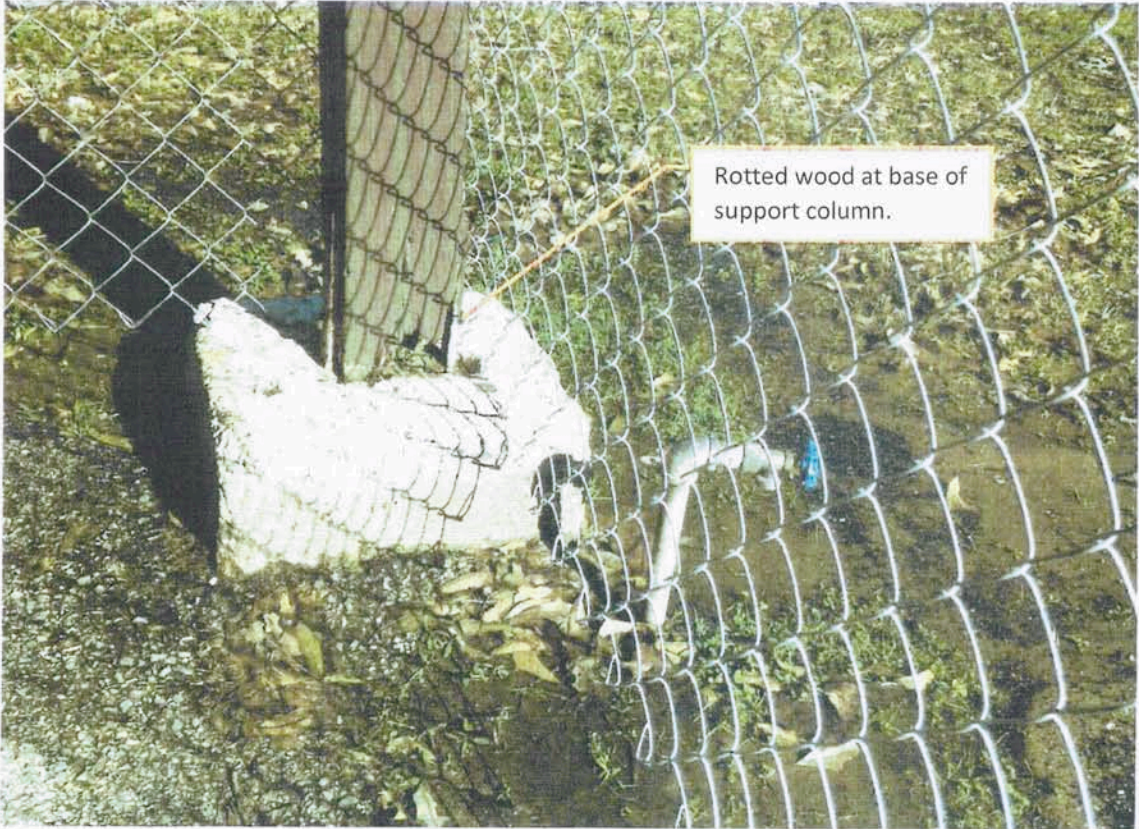
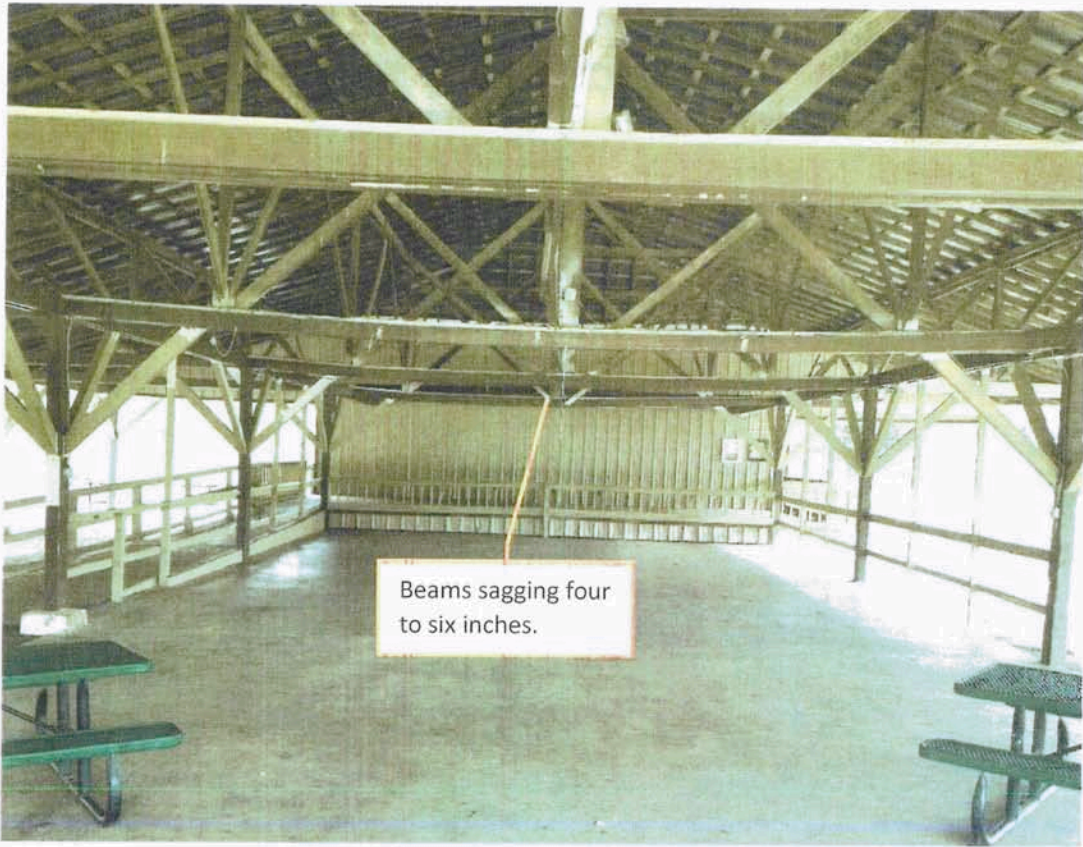
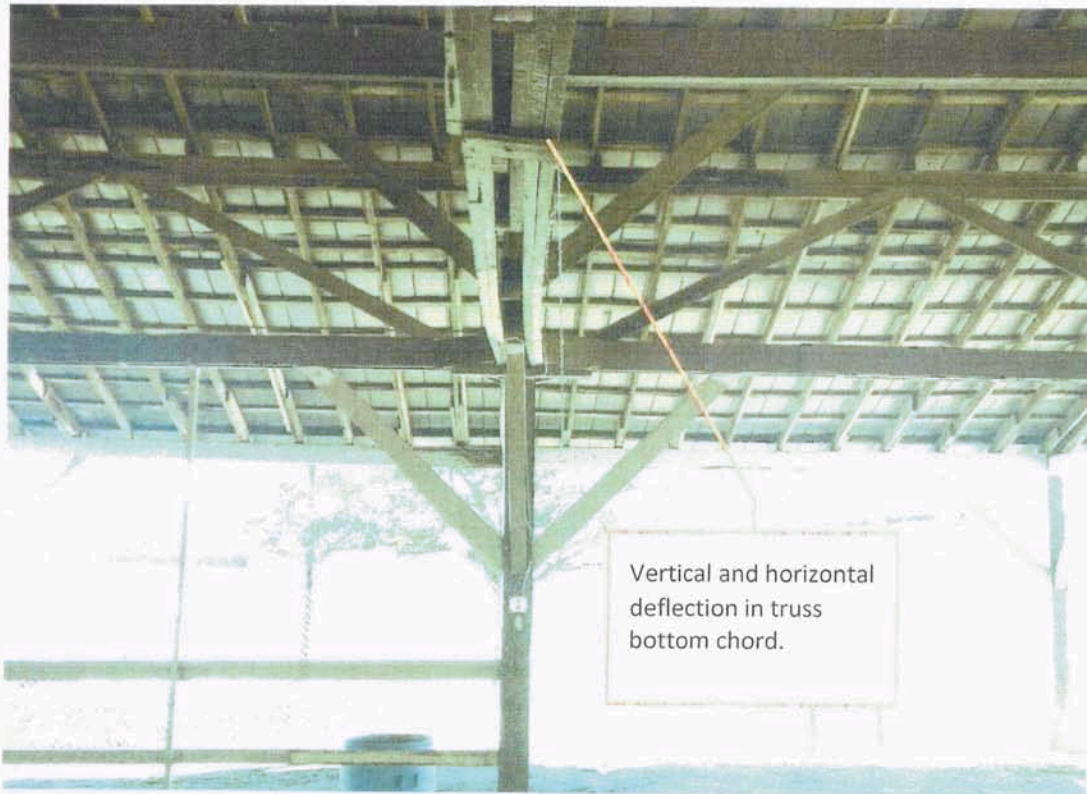
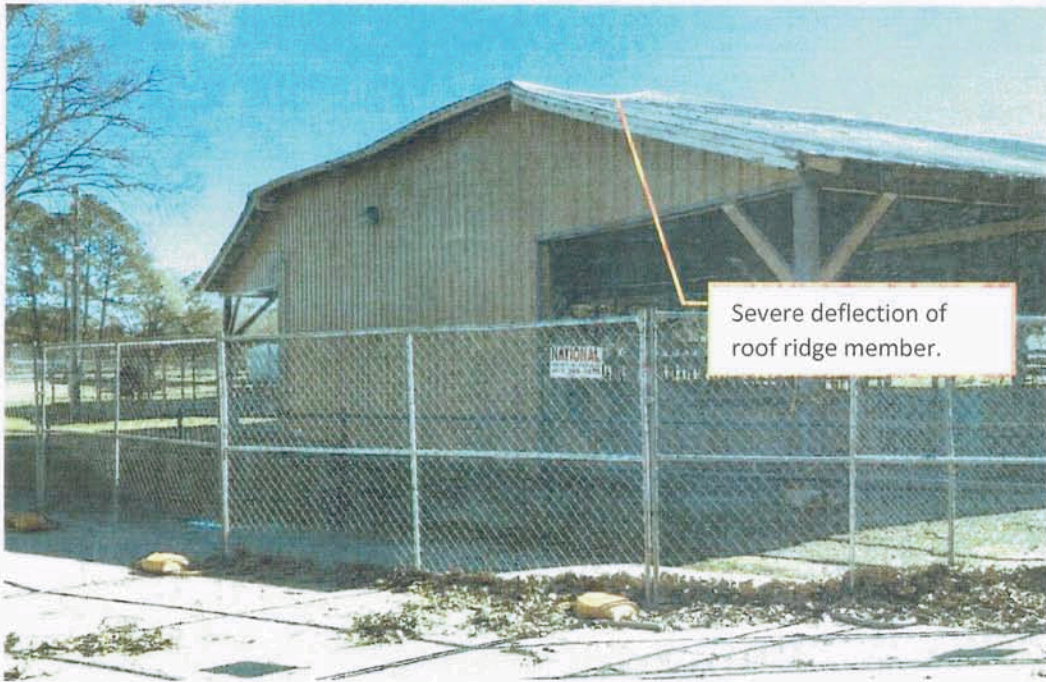
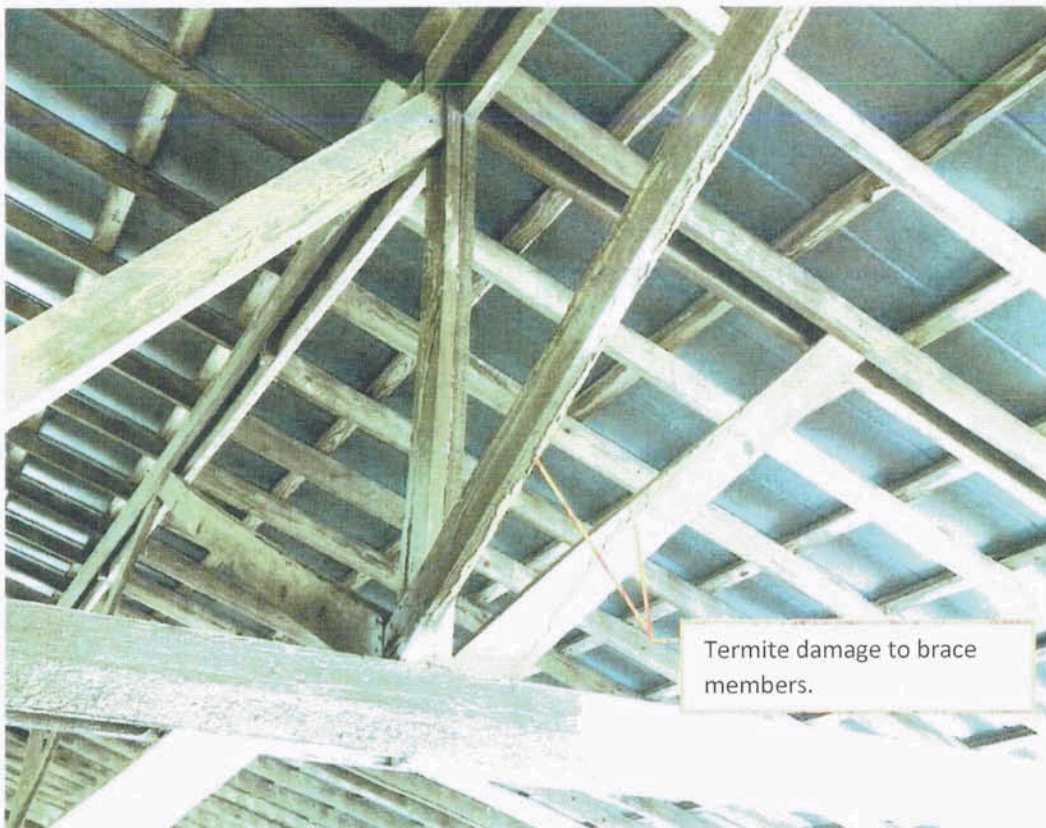
- Rotted column bases and column disconnect from supporting footing.
- Rotated column footings next to drainage channel.
- Sagging and over-stressed structural members with hip members sagging as much as four inches.
- Poorly designed structural framing with all truss bottom chord members deflecting as much as six inches under dead load alone.
- Truss support that has separated and very near to catastrophic failure.
- Rafter support beams that are near failure from movement.
- Under-sized roof rafters.
- Under-sized roof beams.

The two by four rafter members over the center bay are extremely under-designed. The two by six roof rafters at the lower spans are also under-designed. The two by six roof ridge and the roof support beams are under-designed. These members are exhibiting unacceptable deflection.

The lack of co-incidence in the truss framing is causing rotation at the truss joints and in some cases has caused or is contributing to member failure. The truss over the stage has primarily failed with some strut members rotating out of plane and the bottom chord support at the column near catastrophic failure.

The pavilion structure is not safe for public use and should remain closed to access until it can be removed. Replacement or renovation of the existing structure would require it to be taken down to the foundation and completely re-built.
